**LOWER HOUSATONIC RIVER BASIN
SEYMOUR, CONNECTICUT**

**GREAT HILL RESERVOIR DAM
CT 00087**

**PHASE I INSPECTION REPORT
NATIONAL DAM INSPECTION PROGRAM**

AUGUST 1978

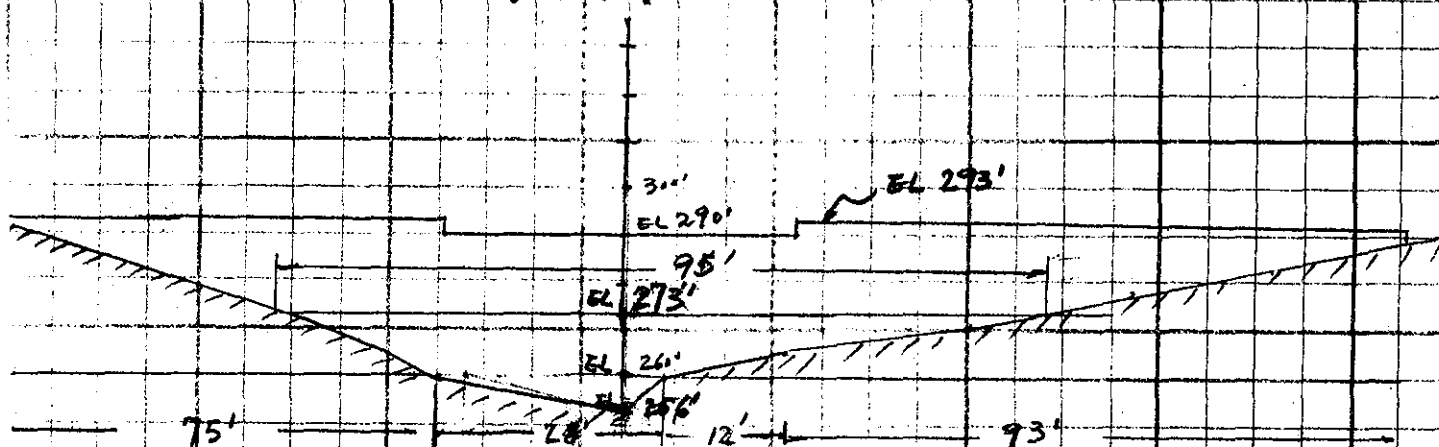
APPROX CROSS SECTION OF DAM (NOT TO SCALE)

ESTIMATION OF BREACH WIDTH MADE ON PLANN FURNISHED BY BIRMINGHAM WATER CO. AUG 16, 1909 APPROX AT EL 273'

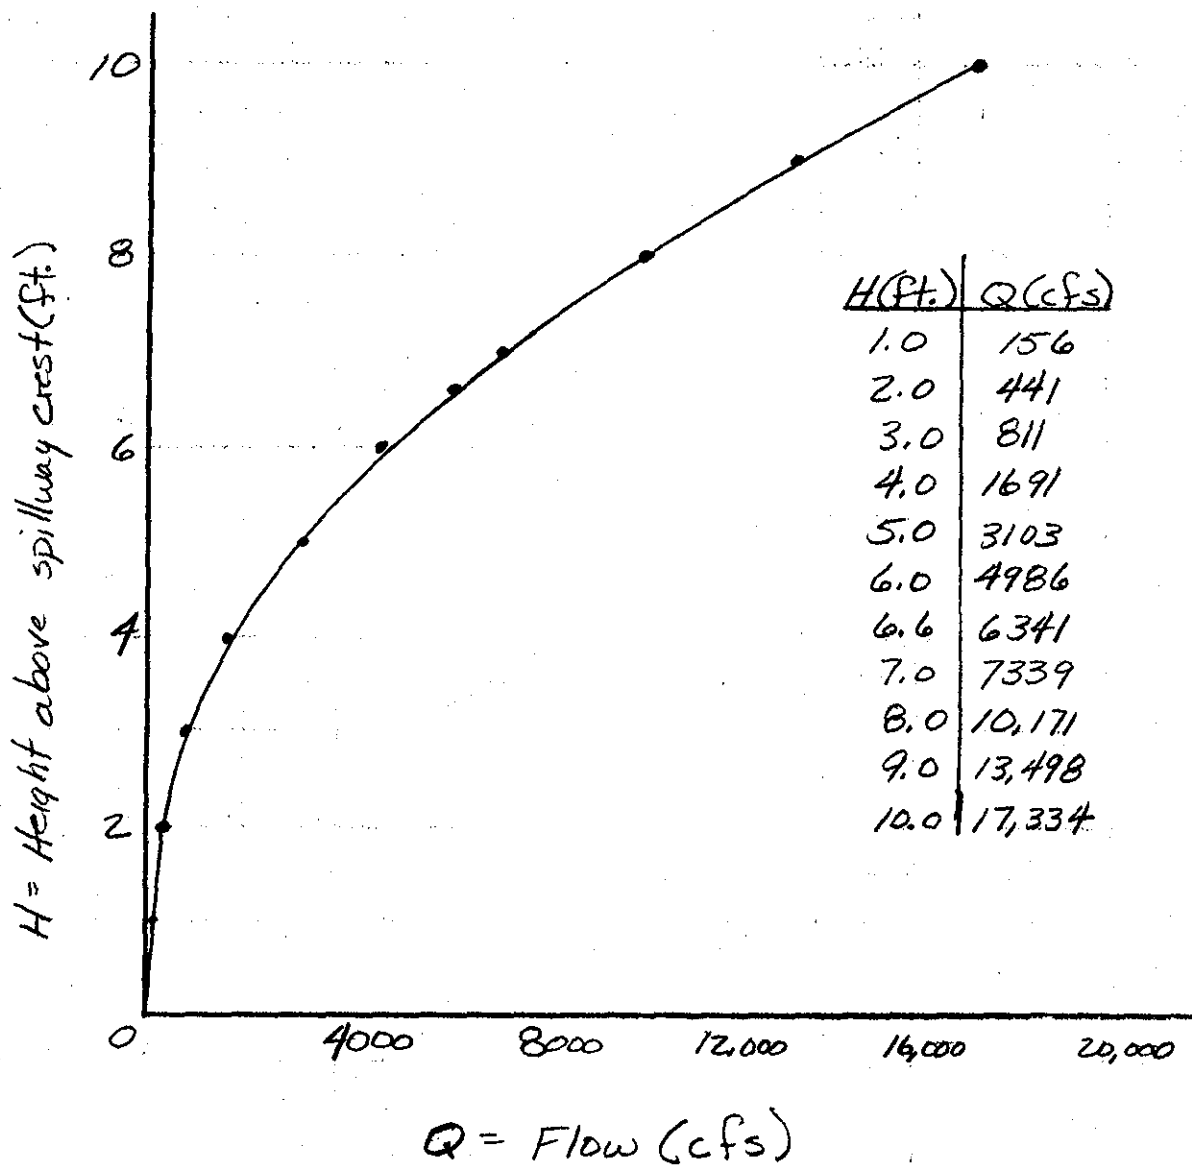
SPILLWAY RATING CURVE

$$Q = 156 H^{3/2} + 405(H-3)^{3/2} + 37.8(H-3)^{5/2}$$
